LIFE SouPLess

Evaluation passive system for riverine micro- and macro-plastics removal

**Report Project Catchy 2 B4
Task <DB.4.3>**

LIFE17 ENV/NL/000339

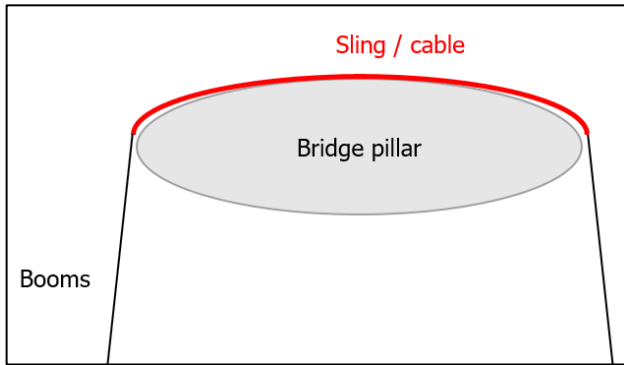
Figure 6: situation with cable and booms

As mentioned earlier, the booms from *Catchy 2* are lashed around a pillar of the Erasmus bridge, see Figure 6. This method is used because Allseas is not allowed to permanently fasten anything to the bridge pillar and other methods such as a ground anchor or a mooring post are not possible at the location of *Catchy 2*. The bridge pillar inflicts friction on the cable, which causes the cable to wear out. This means the cable will have to be replaced after some time.

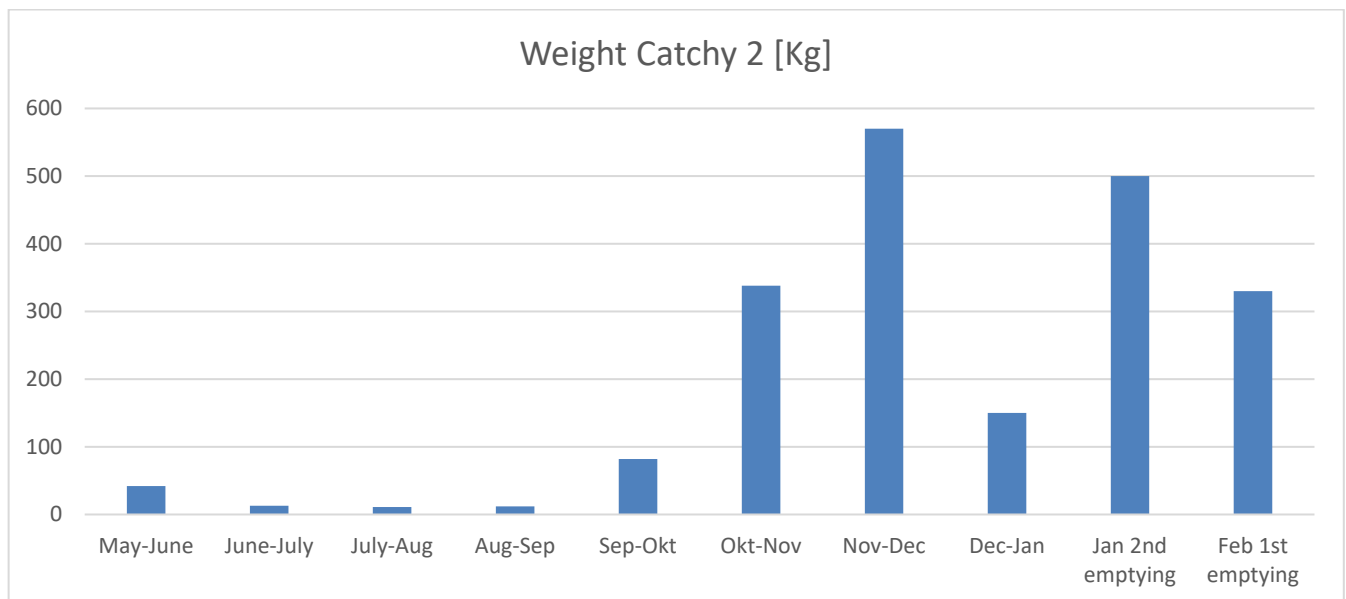
Figure 8, weight of collected litter

In Figure 8, the weights of the collected litter are shown for almost one year. The debris is weighed when wet. It can be concluded that more riverine waste is collected during the autumn and winter months. It is expected that waste accumulates on the riverbanks in summer when the water level is lower. Due to the increase in rainfall during the autumn and winter, the water level rises, and the waste ends up in the river. This, in combination with dying biomass, increases the weight collected by the plastic catcher.

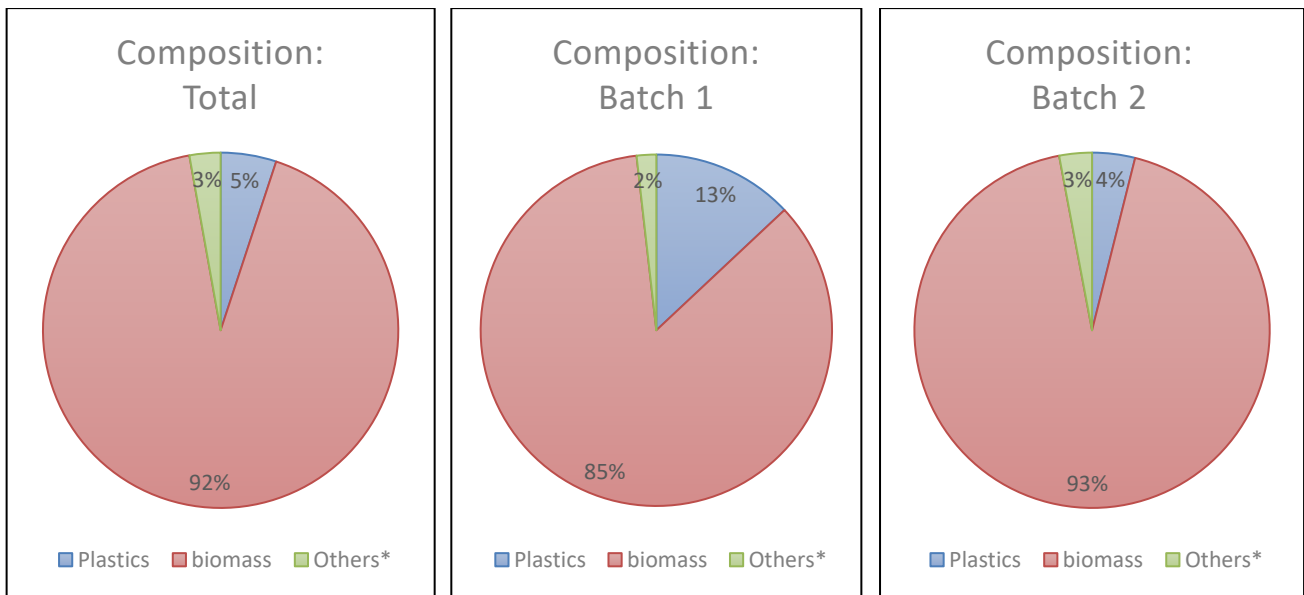
Figure 9, the composition of the collected litter

As shown in Figure 9, the collected litter mainly consists of biomass. On average only 5% of the litter is plastic waste. The other 3% consists of glass and metal. These figures are based on dry weight. Looking back to Catchy this can mean that the biomass is about 30-40% heavier when wet.

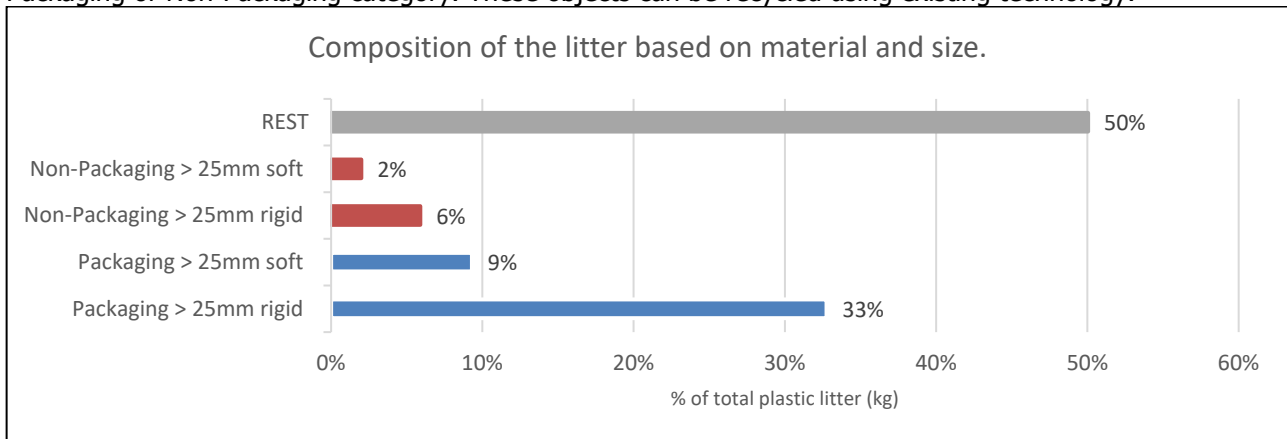
Figure 10, Composition of the litter based on material and size

According to the litter analysis shown in Figure 10, Composition of the litter based on material and size 39% of plastic objects that are larger than 25 mm and made of hard materials such as PE and PP fell into the Packaging or Non-Packaging category. These objects can be recycled using existing technology.

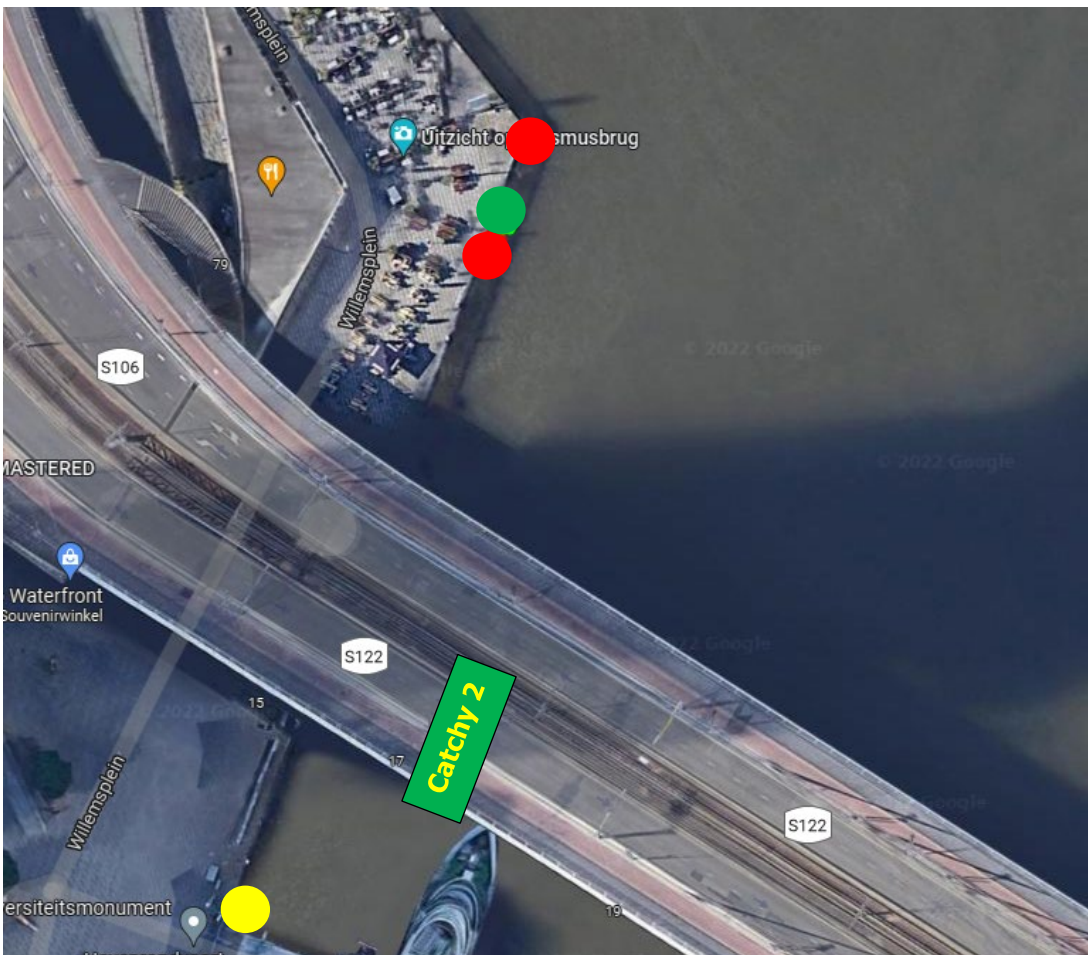
Figure 11, test locations

For the first test the tracers were placed into the river at the **yellow dot** shown in Figure 11 below. The test took long so only one distance was tried after that the current changed to ebb. Circular flow (vortices) near the boom prevented certain tracers to enter the cage, see Figure 12.

The second test was done at the **green dot** in Figure 11. No tracers entered the cage. The booms did not work as the flow was in the wrong direction. Because of this the tracers ended up between the bridge pillar and boom, see Figure 13.

The third and last test was done during good wind and current conditions. The tracers were thrown in the water at the **red dots** in Figure 11. The conditions were good, but practice showed that some tracers ended up between the frame and the quayside. This could happen because there is some space between the quayside and the floating frame.

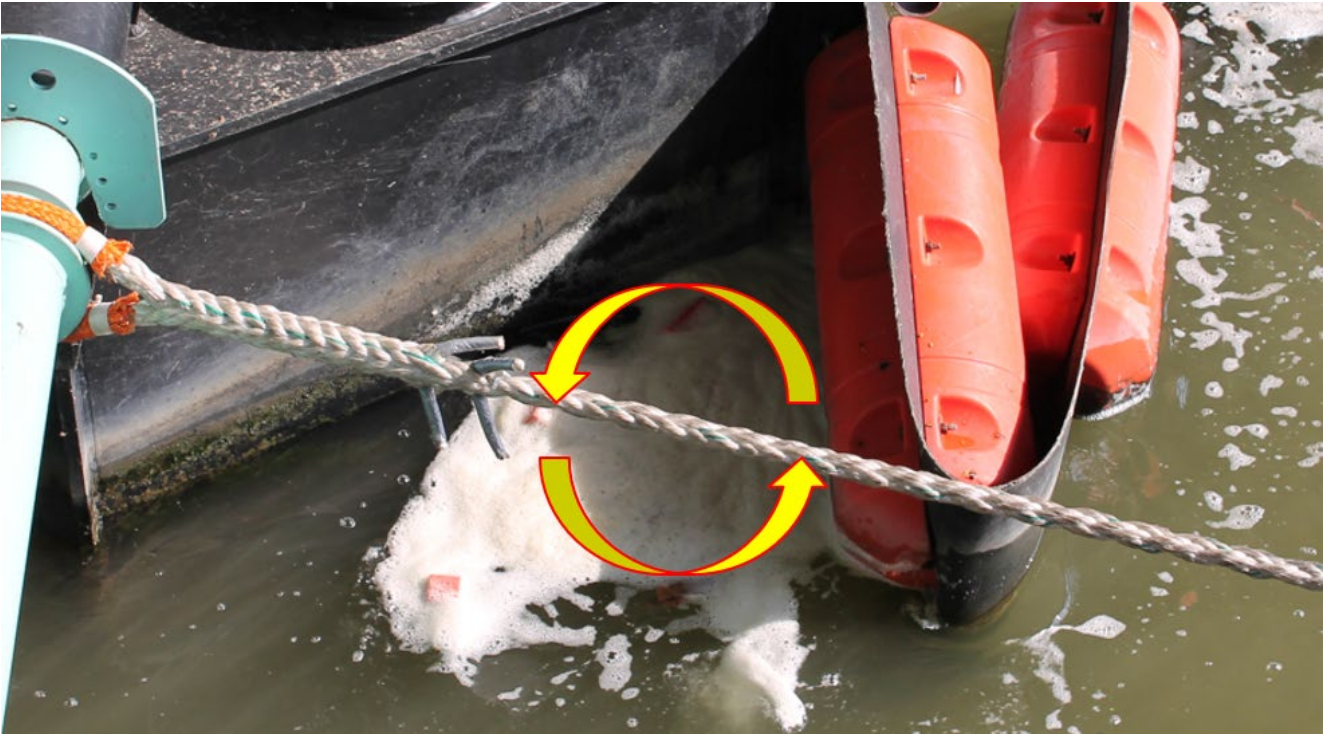
Figure 12: Circular flow behind booms

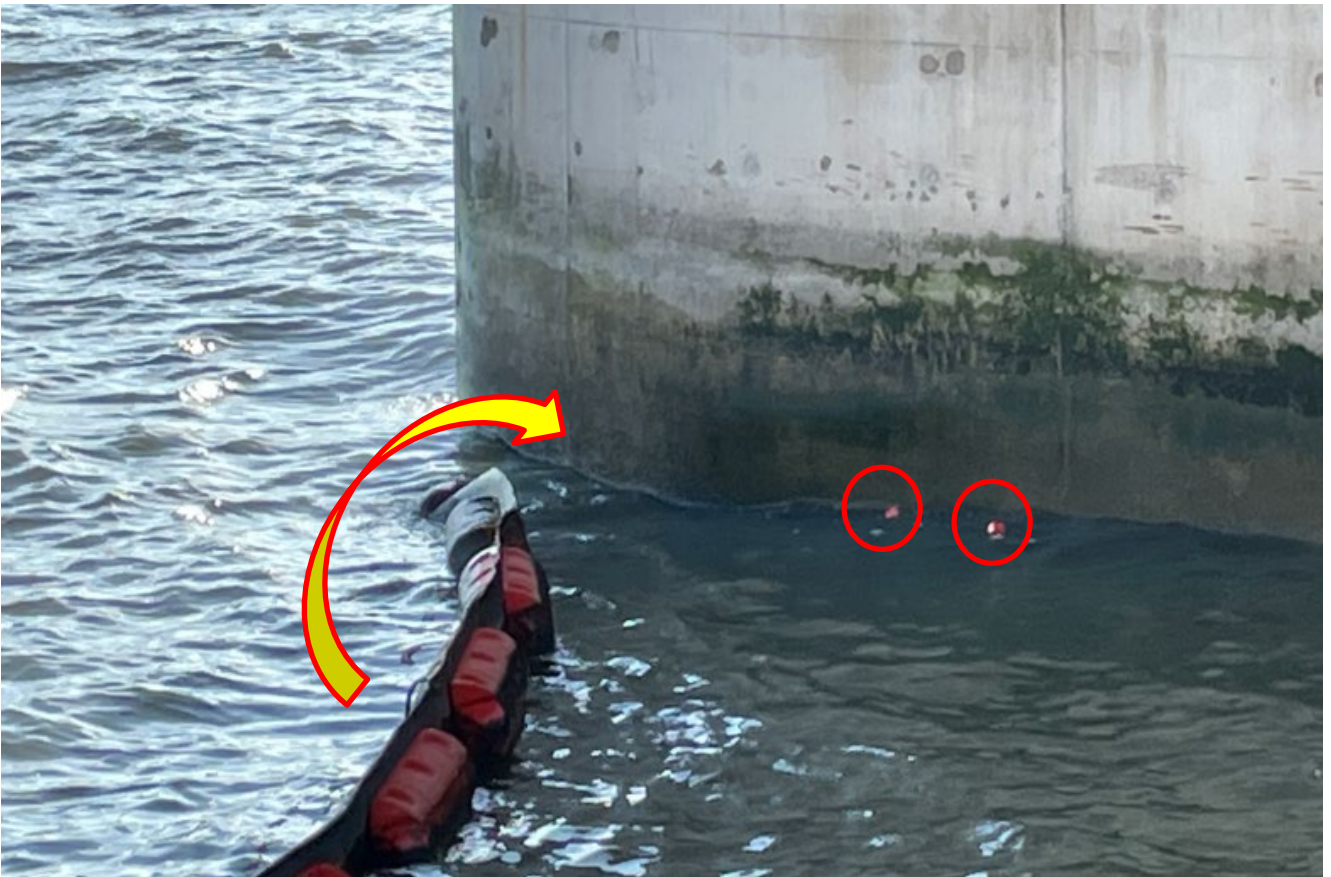
Figure 13: Tracers between bridge pillar and boom
